**Flood Control Project Maintenance  
Levee Inspections**  
**LMA District Cover Sheet**  
**Spring 2012 Levee Inspection Results**

**Plumas County**

Waterway			Bank	Unit Miles
Unit No. 01 North Fork Feather River			Left	1.89
	Spring (March - May)	Summer (June - August)	(September - November) Fall	Winter (December - February)
Unit Maintenance Rating (Fall Only)				
Date of Inspection	4/25/2012 - 4/25/2012			
DWR Inspector	Bob Duffey			
Accompanied By	Jay Pettigrew Plumas Co.

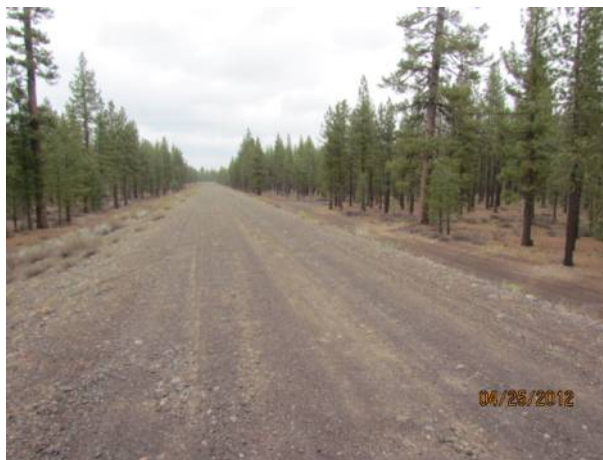
Levee Mile Report Line	4
Start Levee Mile	0.05
End Levee Mile	0.05
Location	Land Side
Category	Earthen Levee
Item	Vegetation

View of native grass on both slopes.

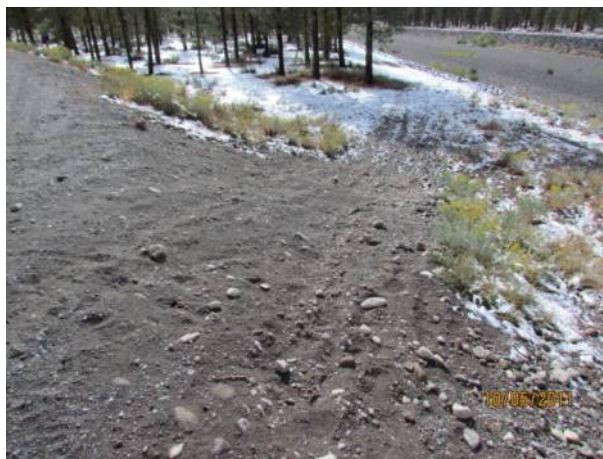
Levee Mile Report Line	5
Start Levee Mile	0.55
End Levee Mile	0.55
Location	Water Side
Category	Earthen Levee
Item	Slope Stability

View of the vehicle erosion along the W/S toe.

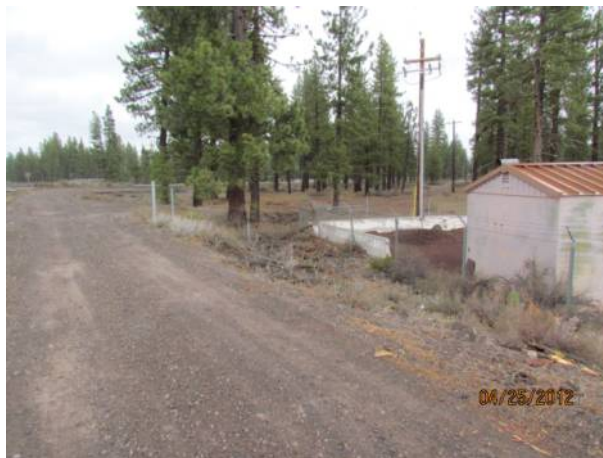
Levee Mile Report Line	6
Start Levee Mile	0.67
End Levee Mile	0.67
Location	Land Side
Category	Earthen Levee
Item	Encroachments

View of the removed pine tree.

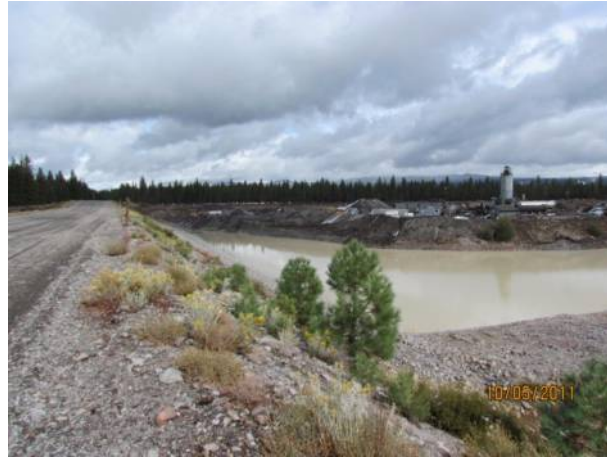
Levee Mile Report Line	7
Start Levee Mile	1.27
End Levee Mile	1.43
Location	Land Side
Category	Earthen Levee
Item	Slope Stability

View of the gravel pit along the L/S toe.

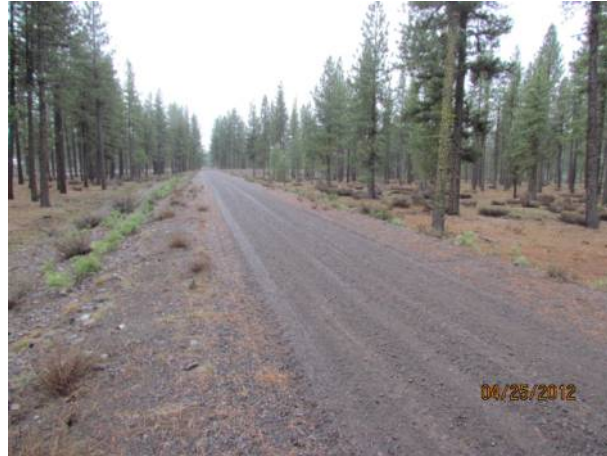
Levee Mile Report Line	1
Start Levee Mile	0.38
End Levee Mile	0.38
Location	Land Side
Category	Earthen Levee
Item	Vegetation

View of the native grass on both slopes.

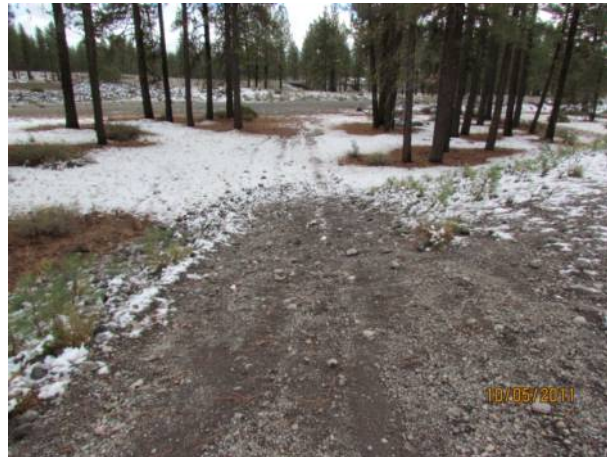
Levee Mile Report Line	2
Start Levee Mile	0.46
End Levee Mile	0.46
Location	Water Side
Category	Earthen Levee
Item	Slope Stability

View of the vehicle erosion along the W/S slope.

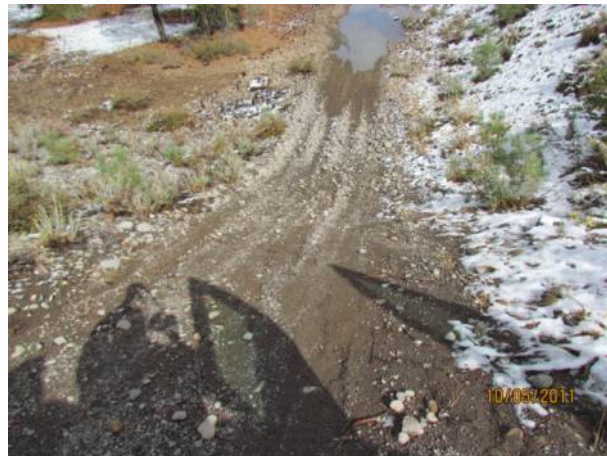
Levee Mile Report Line	3
Start Levee Mile	0.55
End Levee Mile	0.55
Location	Land Side
Category	Earthen Levee
Item	Slope Stability

View of the vehicle erosion along the L/S slope.

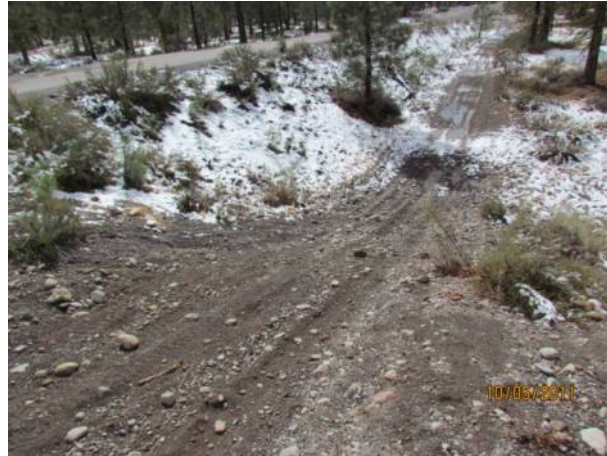
Levee Mile Report Line	4
Start Levee Mile	0.55
End Levee Mile	0.55
Location	Water Side
Category	Earthen Levee
Item	Slope Stability

View of the vehicle erosion along the W/S slope.
